**Flood Control Project Maintenance
Levee Inspections**

2015 Channel Summary Report

Merced Streams Group

Flood Control Project Maintenance**Unit Cover Sheet****2015 Channel Inspection Results****Merced Streams Group**

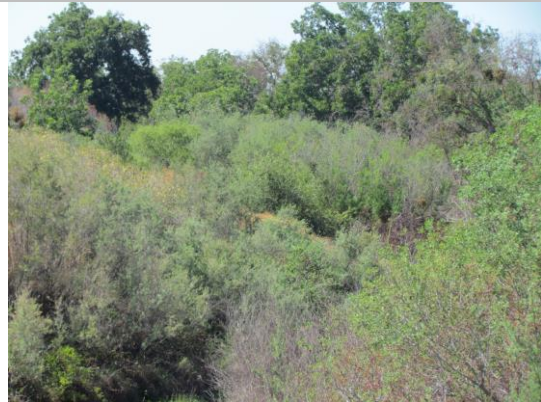
Photo 1 of 1 : CH_2015_NA0013_32_26_20150827_00024.jpg

Arboleda Drive bridge crossing the Bear Creek looking downstream.
The lat/Long is 37.310639,-120.378831

Rating **	U	Issue No.	27	GPS Lat/Long
Issue Type +	Ma	Location *		37.310805 °
Category	Rivers, Channels & Designated Flood			-120.378733 °
Item	Shoaling / Sedimentation			
DWR ID	DWR_NA0013_32_c_2012_27			
Action/Comments				
Inspector Comments: Unsatisfactory wild growth blocks view of channel unable to see the channel for shoaling or sedimentation.

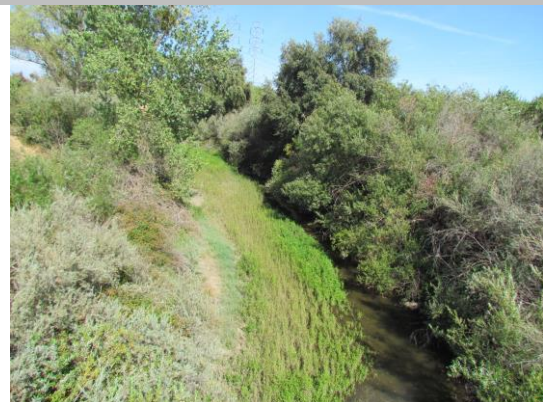
Photo 1 of 1 : CH_2015_NA0013_32_31_20150827_00025.jpg

Kibby Road bridge crossing the Bear Creek.

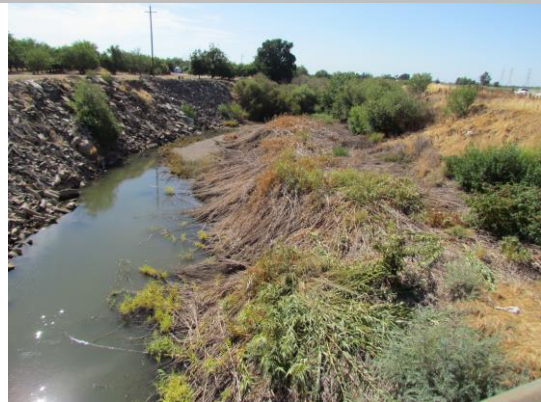
Photo 1 of 1 : CH_2015_NA0013_32_36_20150828_00026.jpg

kibby Road crossing looking downstream.

Rating **	U	Issue No.	37	GPS Lat/Long
Issue Type +	Ma	Location *		37.311970 °
Category	Rivers, Channels & Designated Flood			-120.415350 °
Item	Shoaling / Sedimentation			
DWR ID	DWR_NA0013_32_c _ 2012_37			
Action/Comments				
Inspector Comments: There is sedimentation build up in channel that has weeds and unwanted brush growing on it . Refer to photo in issue # 36.

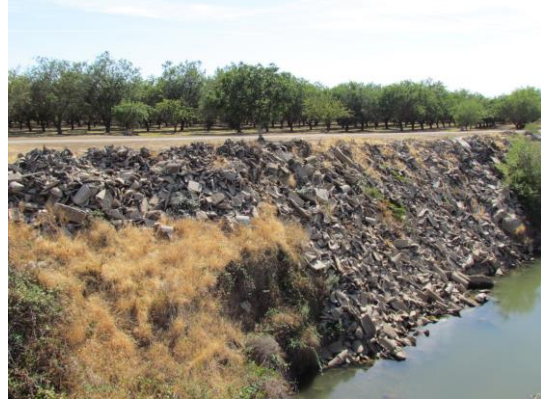
Photo 1 of 1 : CH_2015_NA0013_32_38_20150828_00027.jpg

Inspector Comments: MID repaired the erosion site listed in 2014 channel Report. The repairs were done prior to 2015 inspection.

Bear Creek downstream of Kibby Rd crossing. From 37.312004,-120.415182 to 37.312420,-120.415942 erosion site.

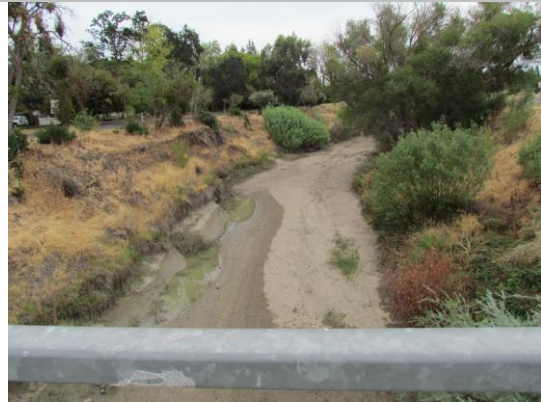
Photo 1 of 1 : CH_2015_NA0013_32_41_20150828_00028.jpg

Bear Creek Upstream of Mc Kee Road crossing.

Rating **	A	Issue No.	42	GPS Lat/Long
Issue Type +	Ma	Location *		37.309600 °
Category	Rivers, Channels & Designated Flood			-120.444500 °
Item	Shoaling / Sedimentation			
DWR ID	DWR_NA0013_32_c _ 2012_42			
Action/Comments				
Inspector Comments: No shoaling or sedimentation present.

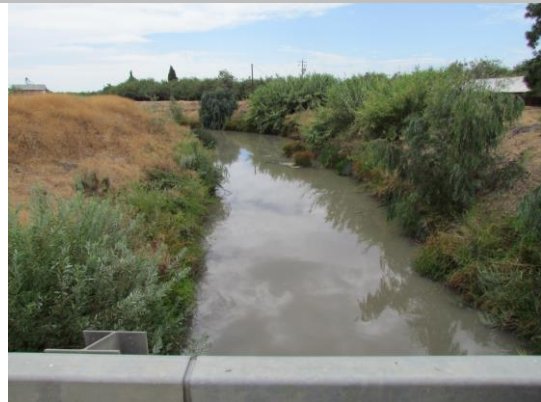
Photo 1 of 1 : CH_2015_NA0013_32_66_20150828_00035.jpg

Bear Creek looking downstream from Franklin Road crossing.

Rating **	A	Issue No.	67	GPS Lat/Long
Issue Type +	Ma	Location *		37.311400 °
Category	Rivers, Channels & Designated Flood			-120.541000 °
Item	Shoaling / Sedimentation			
DWR ID	DWR_NA0013_32_c _ 2012_67			
Action/Comments				
Inspector Comments: No shoaling or sedimentation at this location.

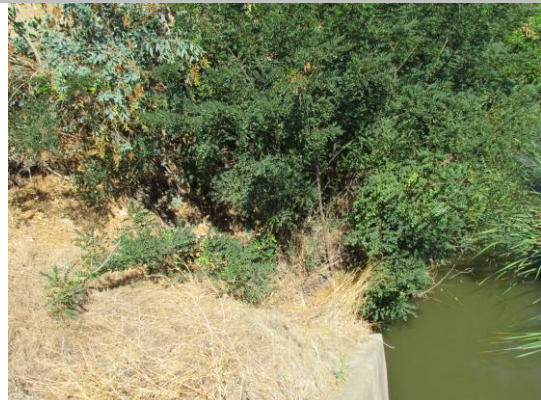
Photo 1 of 1 : CH_2015_NA0013_33_18_20150820_00024.jpg

Erosion present under brush at the left bank abutment downstream of structure.

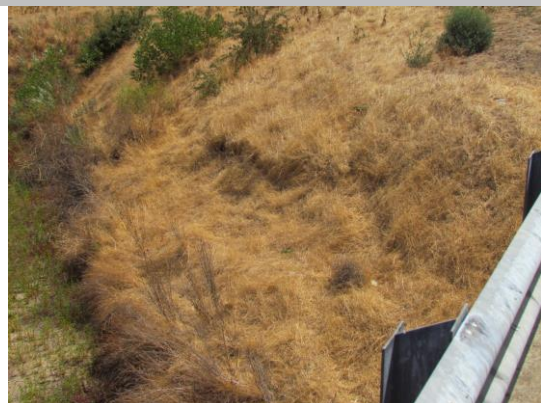
Photo 1 of 1 : CH_2015_NA0013_33_63_20150826_00035.jpg

Black Rascal Creek Oak Avenue bridge crossing, there is erosion present on the right bank slope.

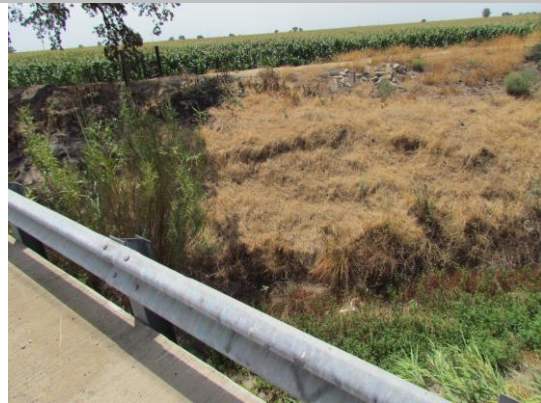
Photo 1 of 1 : CH_2015_NA0013_33_68_20150826_00037.jpg

Erosion present on the left bank midway up the slope downstream from the bridge crossing.

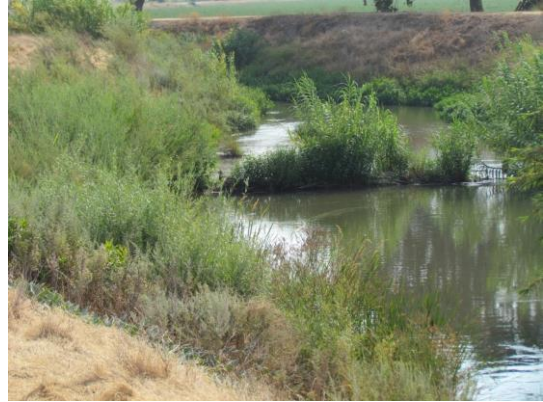
Photo 1 of 1 : CH_2015_NA0013_33_76_20150611_00020.jpg

Looking at the confluence of the Black Rascal and the Bear Creek young willow trees and other vegetation growth present in channel.

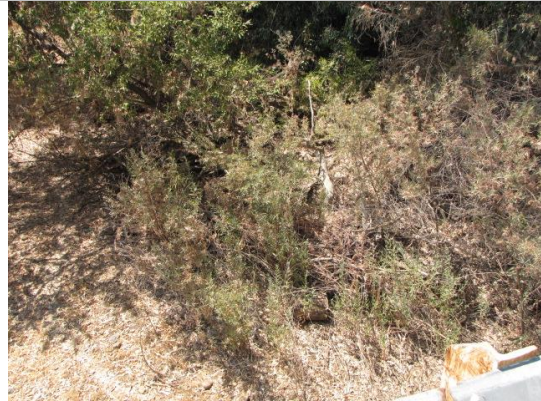
Photo 1 of 1 : CH_2015_NA0013_35_20_20150611_00005.jpg

Wild growth in channel along with firewood piled up in channel downstream from bridge crossing.

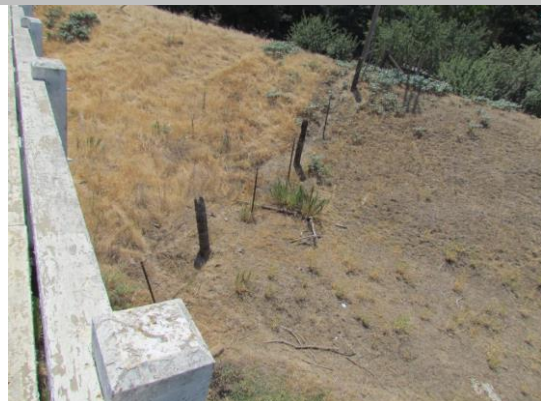
Photo 1 of 2 : CH_2015_NA0013_35_50_20150611_00013.jpg

Fence present under bridge left bank crossing channel.

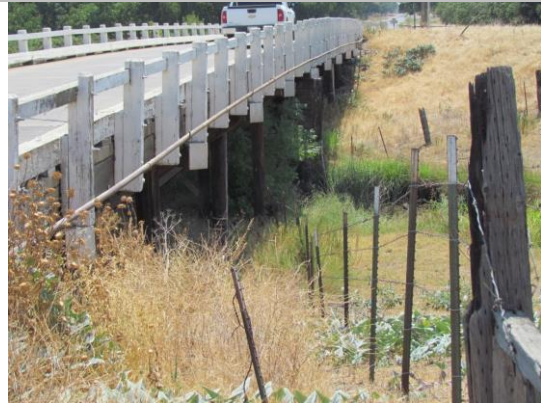
Photo 2 of 2 : CH_2015_NA0013_35_50_20150611_00012.jpg

Fence continues up the slope of the right bank.

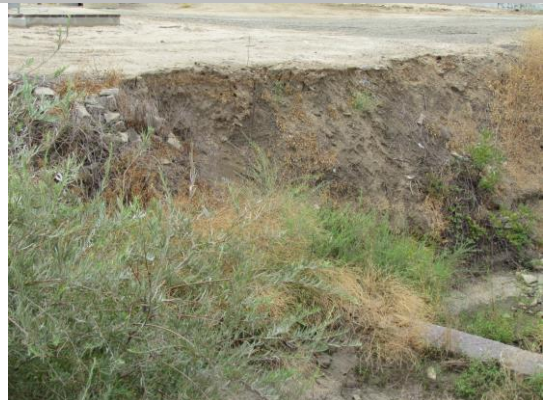
Photo 1 of 1 : CH_2015_NA0013_35_78_20150827_00043.jpg

Mariposa Creek left bank erosion repaired.

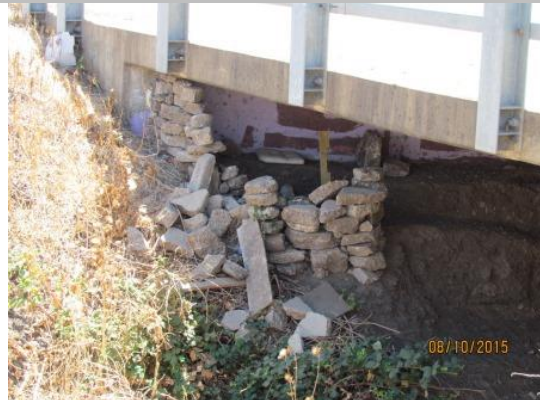
Photo 1 of 1 : CH_2015_NA0013_36_5_20150812_00033.jpg

View of the stacked concrete blocks under the bridge.

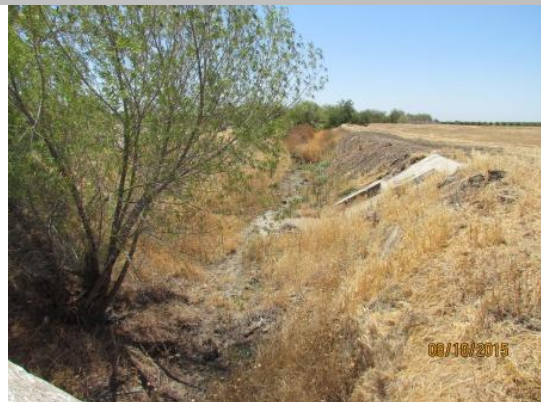
Photo 1 of 1 : CH_2015_NA0013_36_26_20150812_00037.jpg

Plainsburg Rd crossing, downstream view, Note woody vegetation on left side of channel.

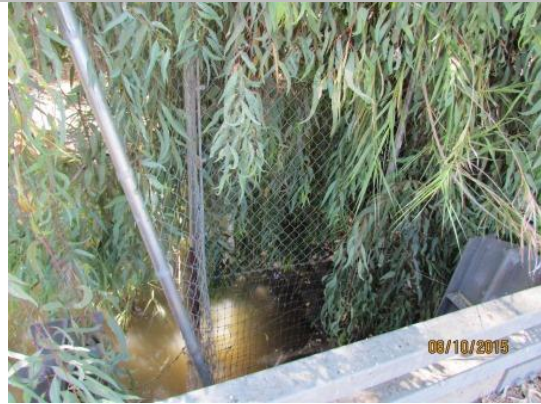
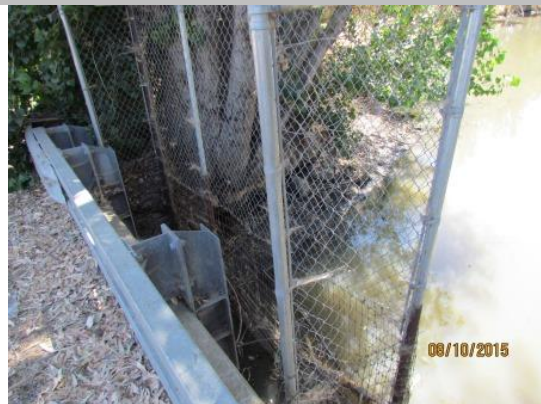
View of the chain link fence encroaching into the channel on the left bank.

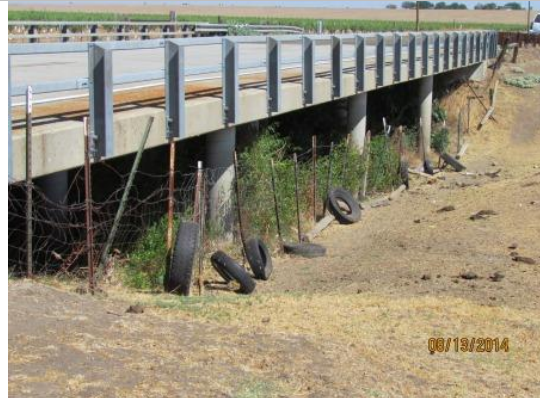
Photo 1 of 1 : CH_2015_NA0013_37_5_20150812_00002.jpg

Wire fence on upstream side of Cunningham crossing.

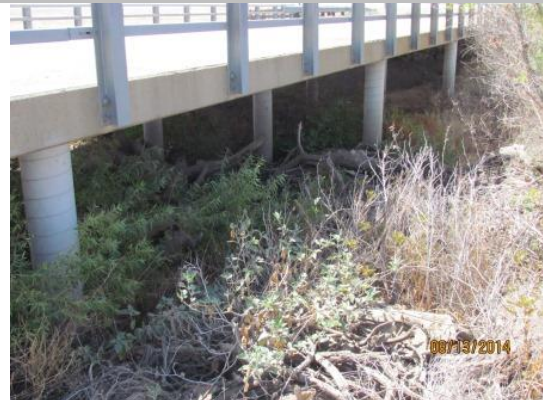
Photo 1 of 1 : CH_2015_NA0013_37_10_20150812_00004.jpg

Debris and vegetation accumulated under bridge.

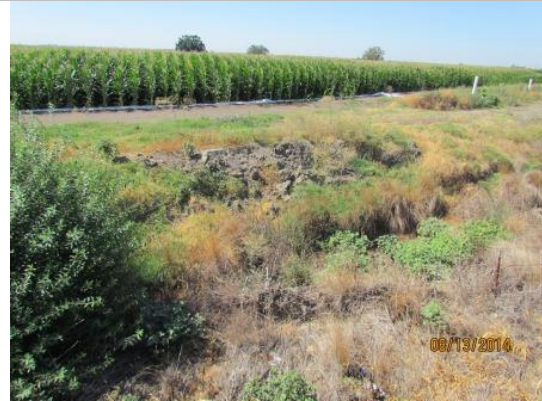
Photo 1 of 1 : CH_2015_NA0013_37_18_20150812_00007.jpg

View of the repaired erosion site.

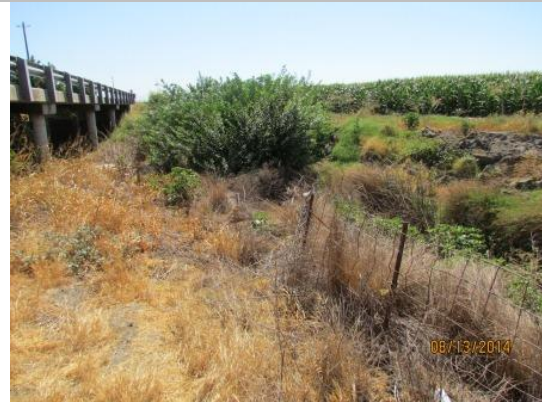
Photo 1 of 1 : CH_2015_NA0013_37_20_20150812_00008.jpg

View of the wire fence across the channel downstream of Childs Ave. crossing.

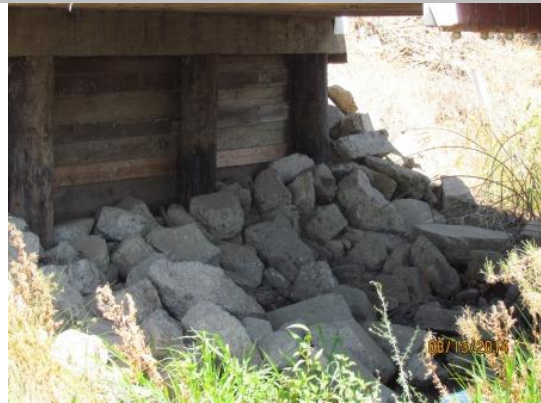
Photo 1 of 1 : CH_2015_NA0013_37_29_20150812_00011.jpg

View of the riprap in the channel at Mission Ave crossing.

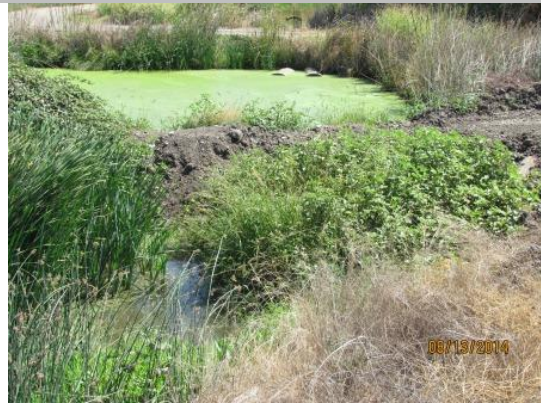
Photo 1 of 1 : CH_2015_NA0013_37_35_20150812_00013.jpg

Photo shows what appears to be material placed in the channel, material is overgrown with vegetation.
